LAWRENCE
LIVERMORE
NATIONAL
LABORATORY

LLNL-TR-648143

A Visual Description of the Concrete Exterior of the Cactus Crater Containment Structure

October 2013

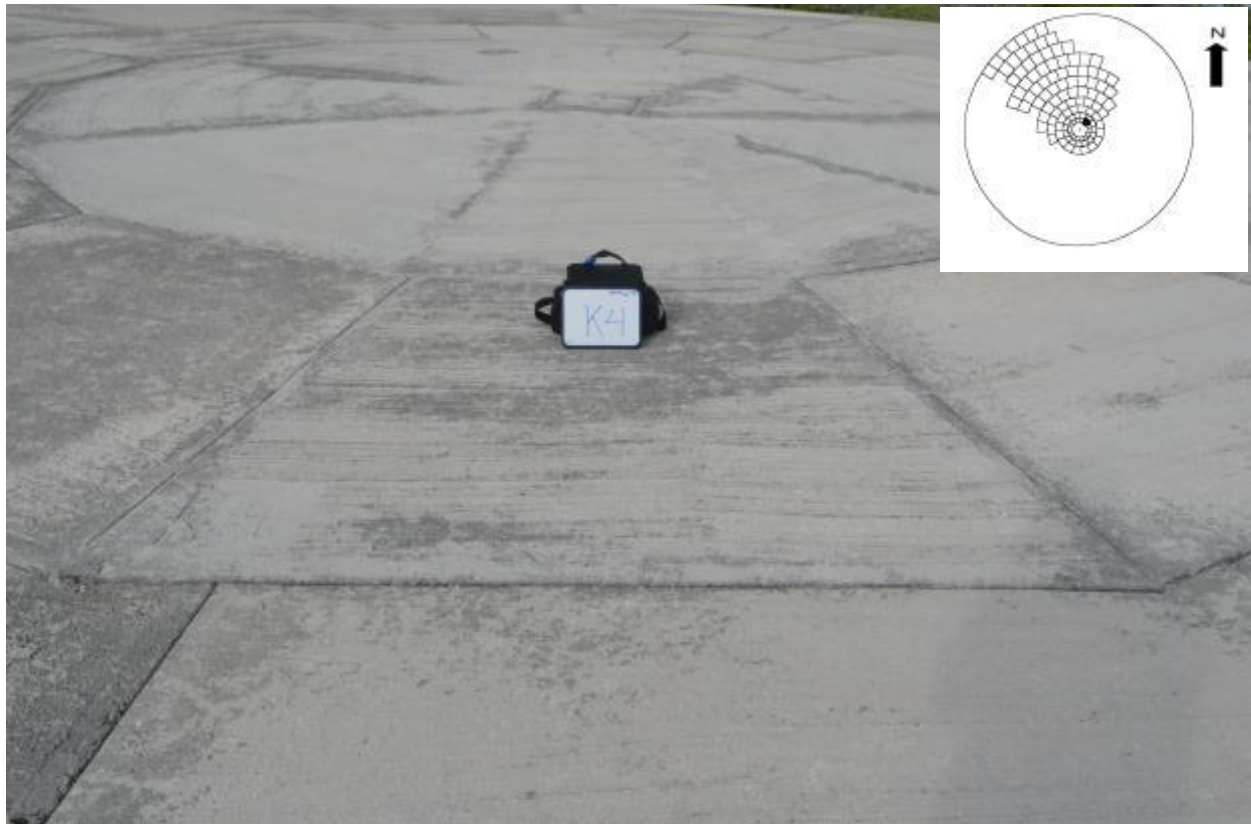
CAP SECTION LOCATION: Panel K4

No significant or obvious interior cracks or spall elements identified.

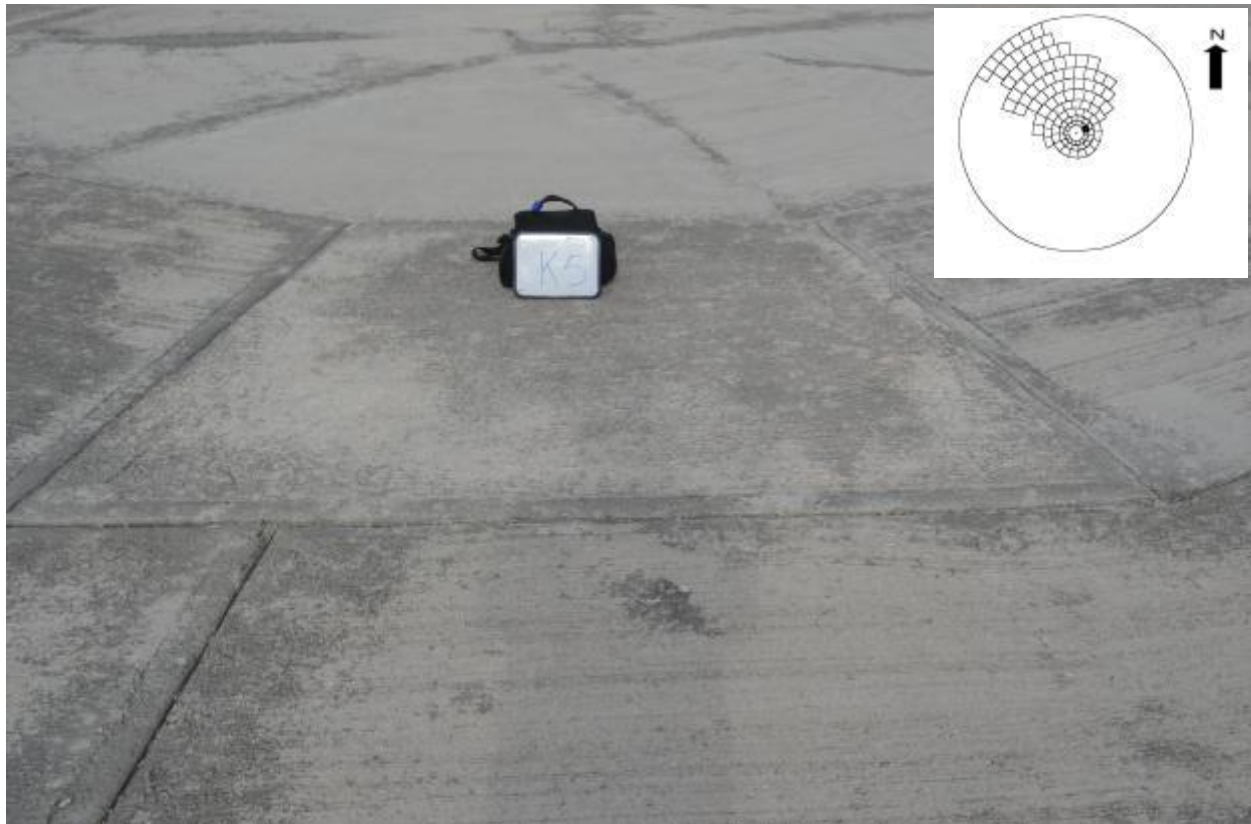
CAP SECTION LOCATION: Panel K5

No significant or obvious interior cracks or spall elements identified.

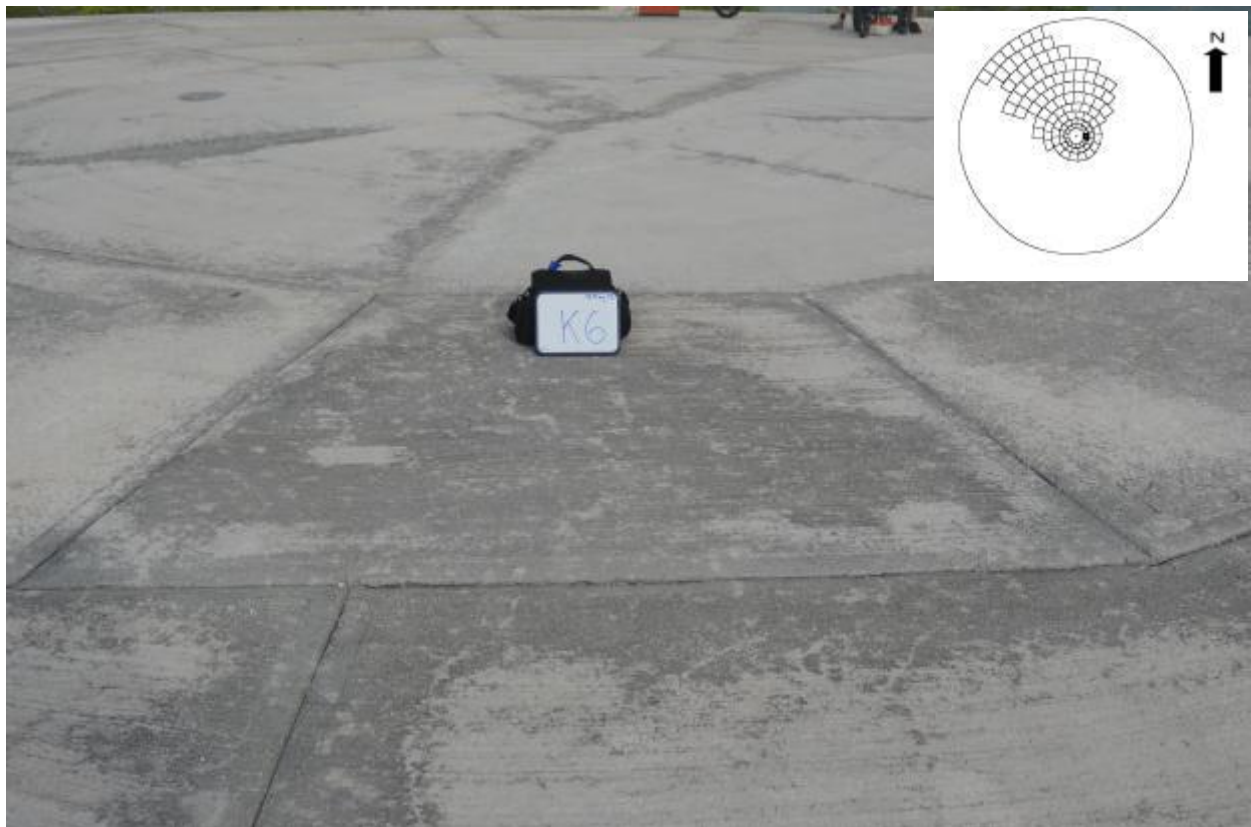
CAP SECTION LOCATION: Panel K6

No significant or obvious interior cracks or spall elements identified.

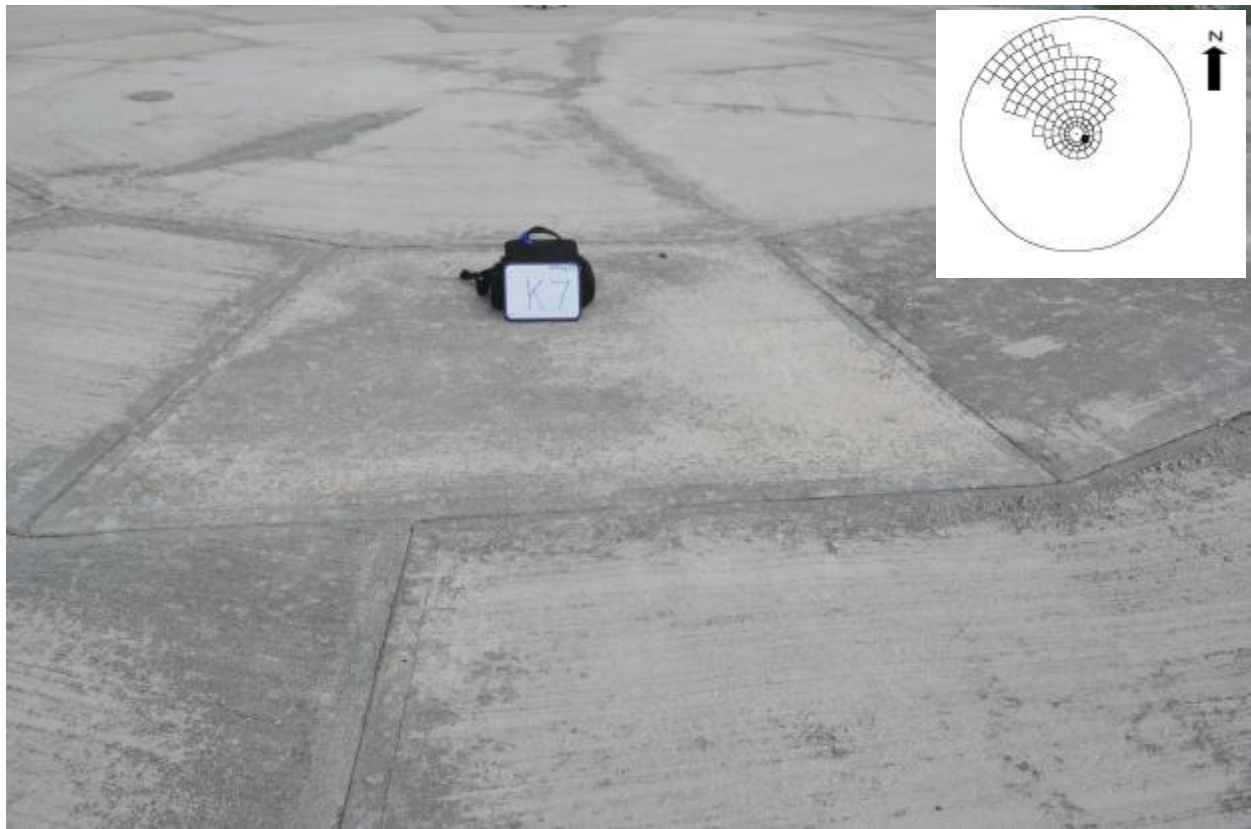
CAP SECTION LOCATION: Panel K7

No significant or obvious interior cracks or spall elements identified with exception of a small void in the concrete in the upper right corner (app. 2 centimeters deep, and 3 x 4 centimeters in area).

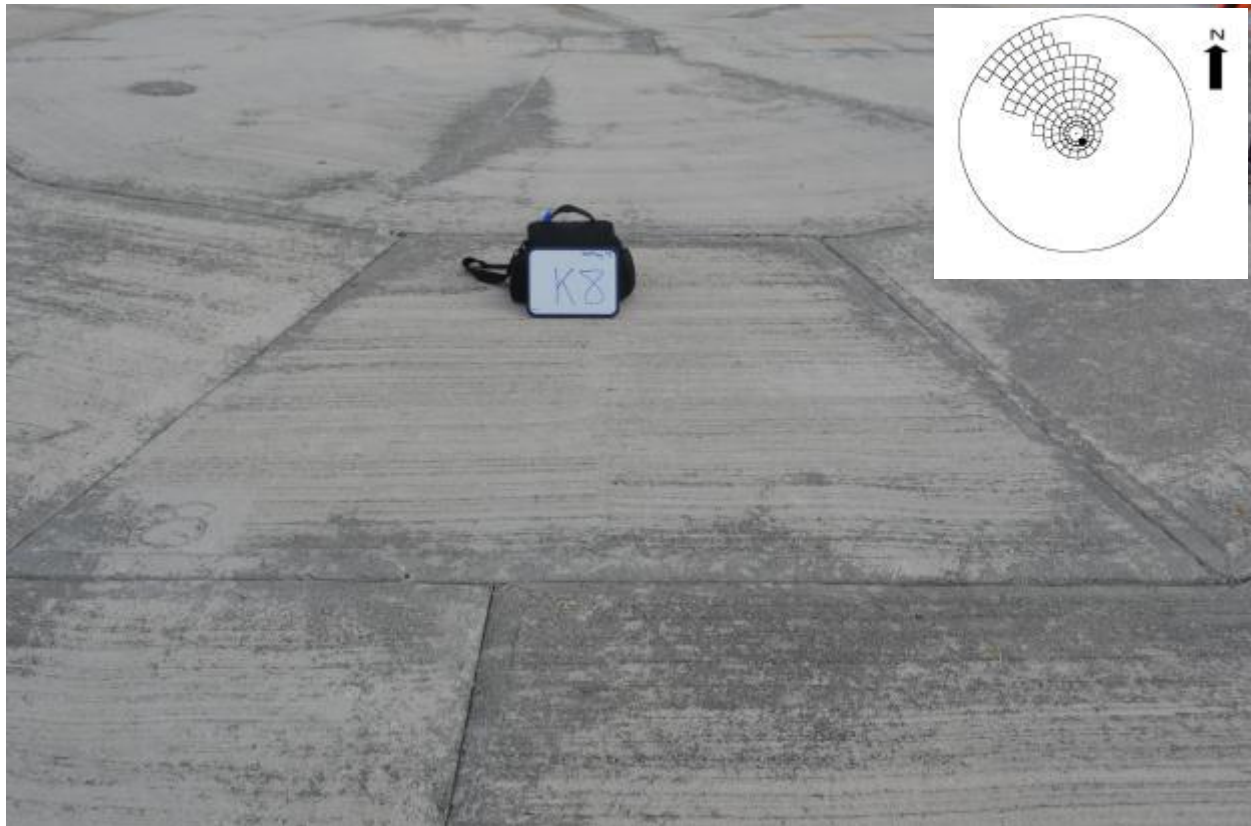
CAP SECTION LOCATION: Panel K8

No significant or obvious interior cracks or spall elements identified.

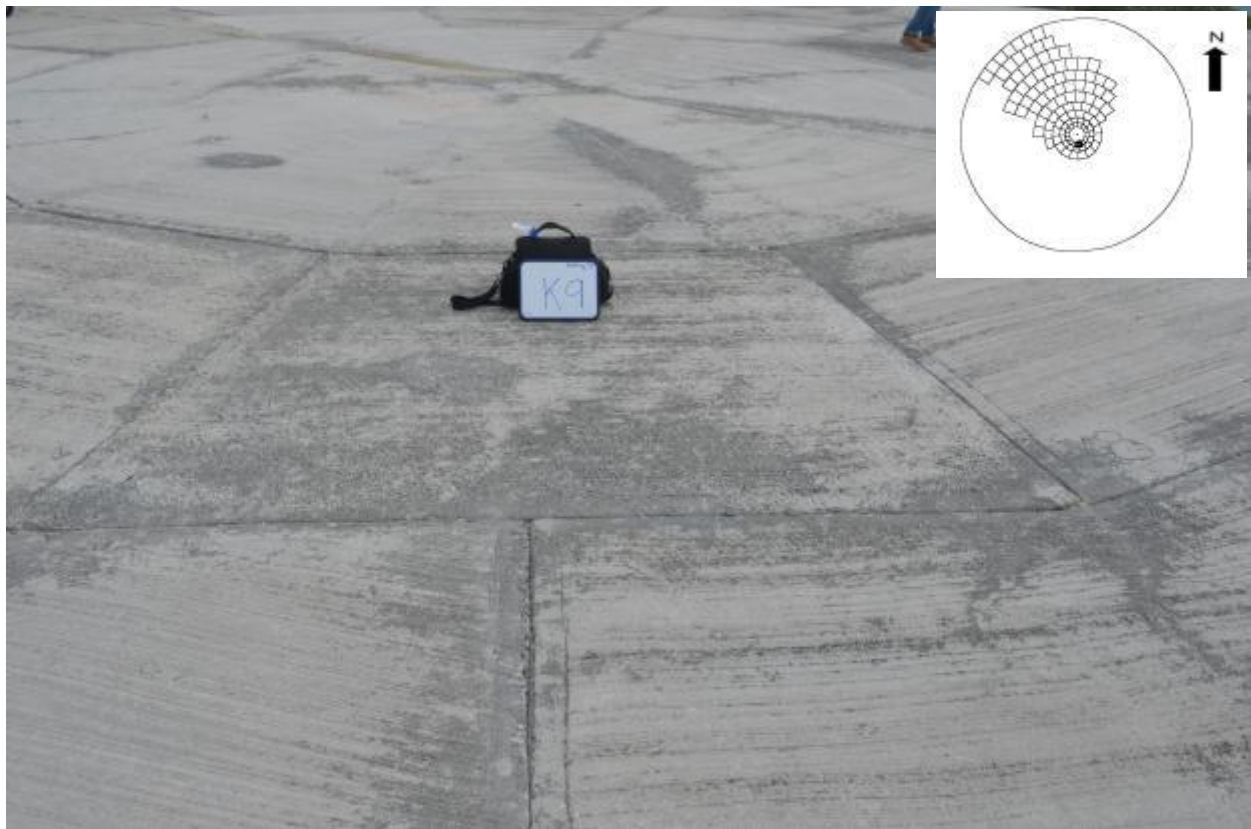
CAP SECTION LOCATION: Panel K9

No significant or obvious interior cracks or spall elements identified. Some very minor spalling/cracking observed in the upper and lower right corners.

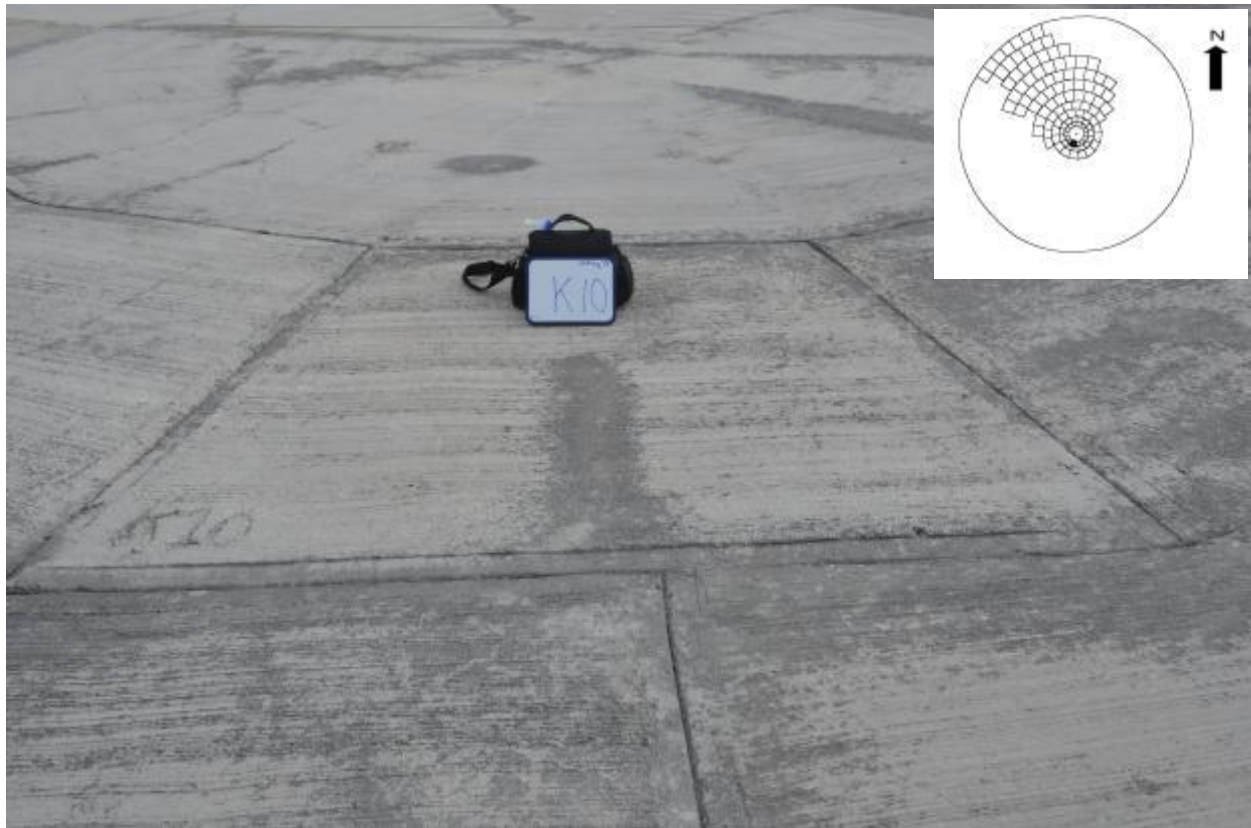
CAP SECTION LOCATION: Panel K10

No significant or obvious interior cracks or spall elements identified.

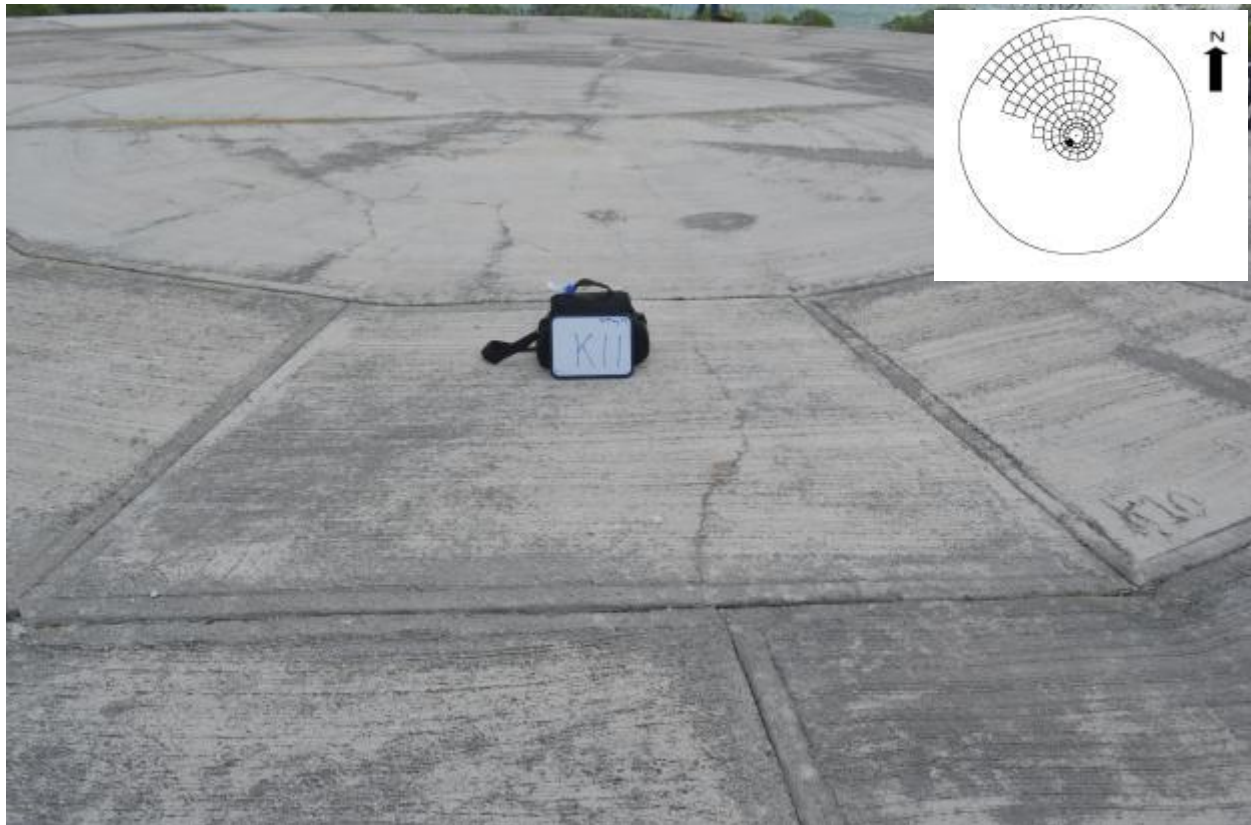
CAP SECTION LOCATION: Panel K11

Surface crack observed running up the entire length of panel and originating from near the corner intersection of the panels on the ring row below.

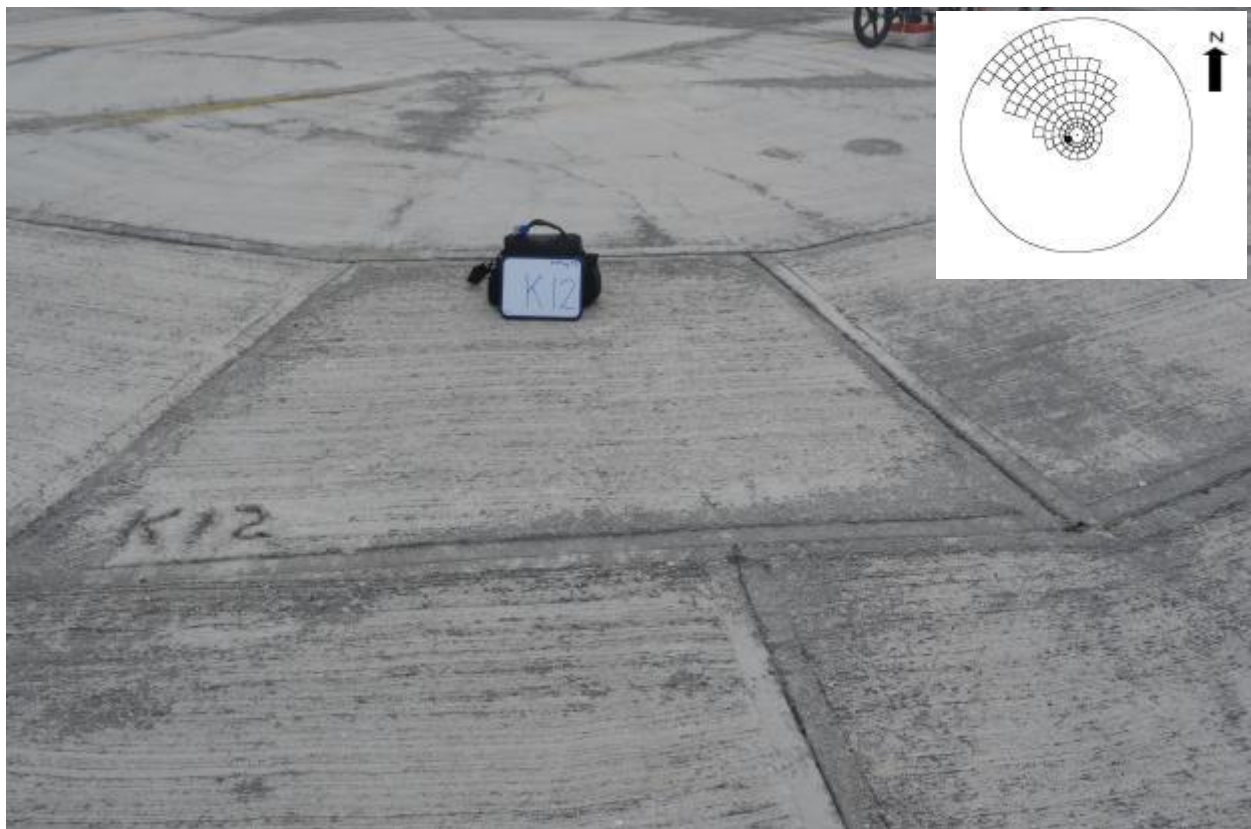
CAP SECTION LOCATION: Panel K12

No significant or obvious interior cracks or spall elements identified.

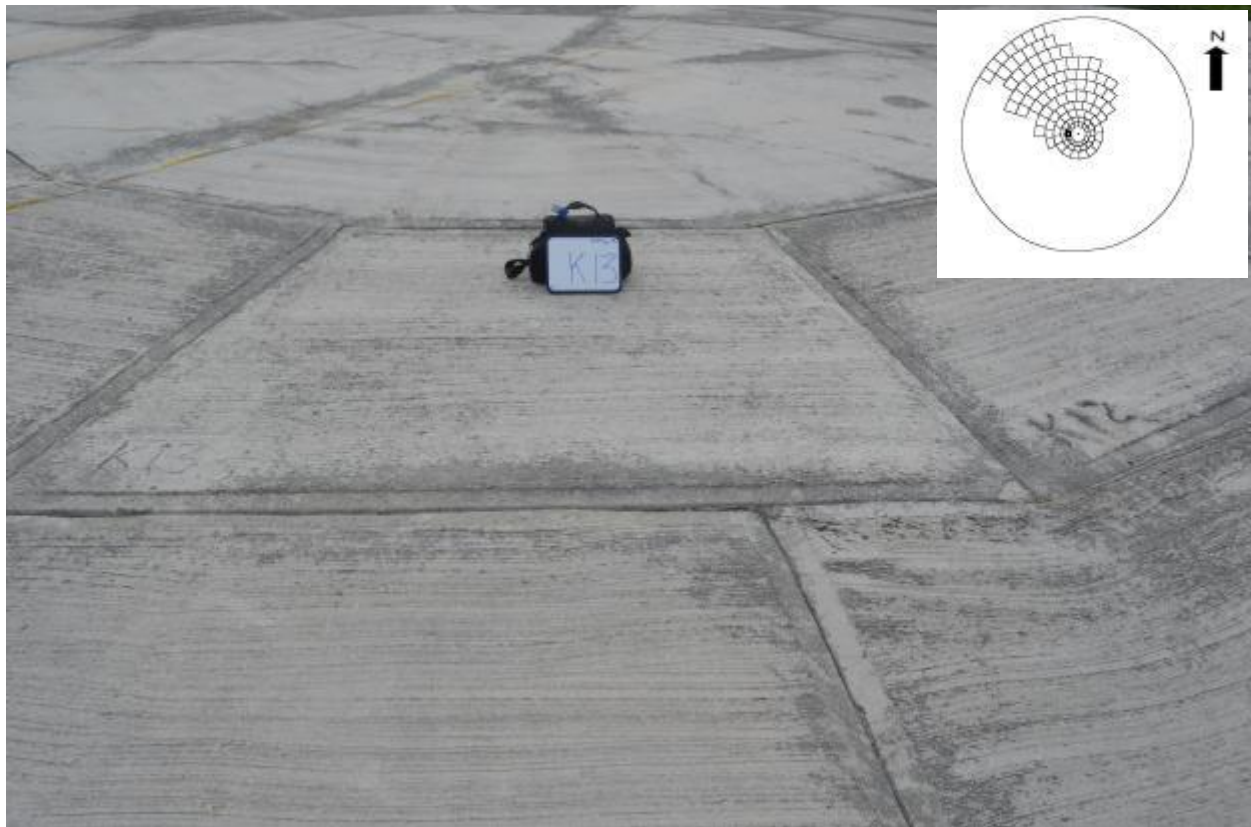
CAP SECTION LOCATION: Panel K13

No significant or obvious interior cracks or spall elements identified with exception of very minor spalling/cracking in the lower right corner of the panel.

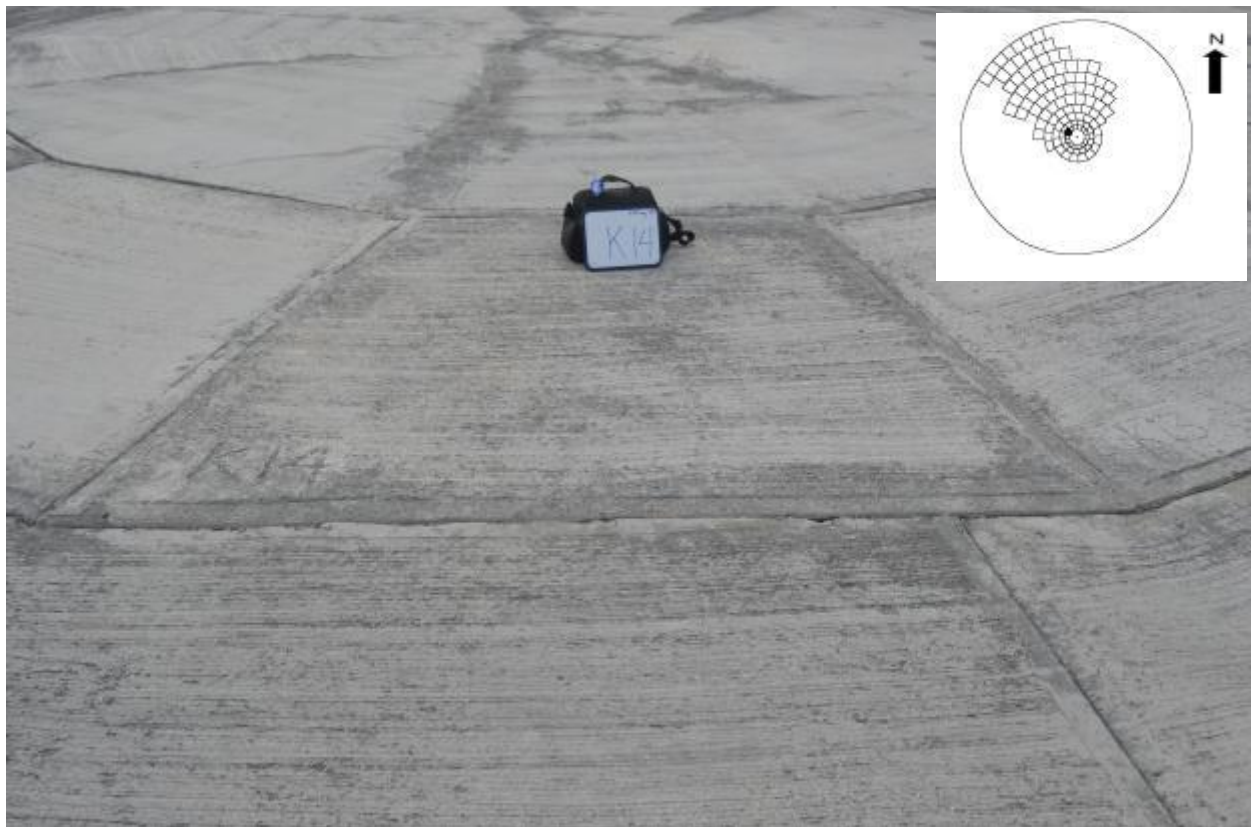
CAP SECTION LOCATION: Panel K14

No significant or obvious interior cracks or spall elements identified.

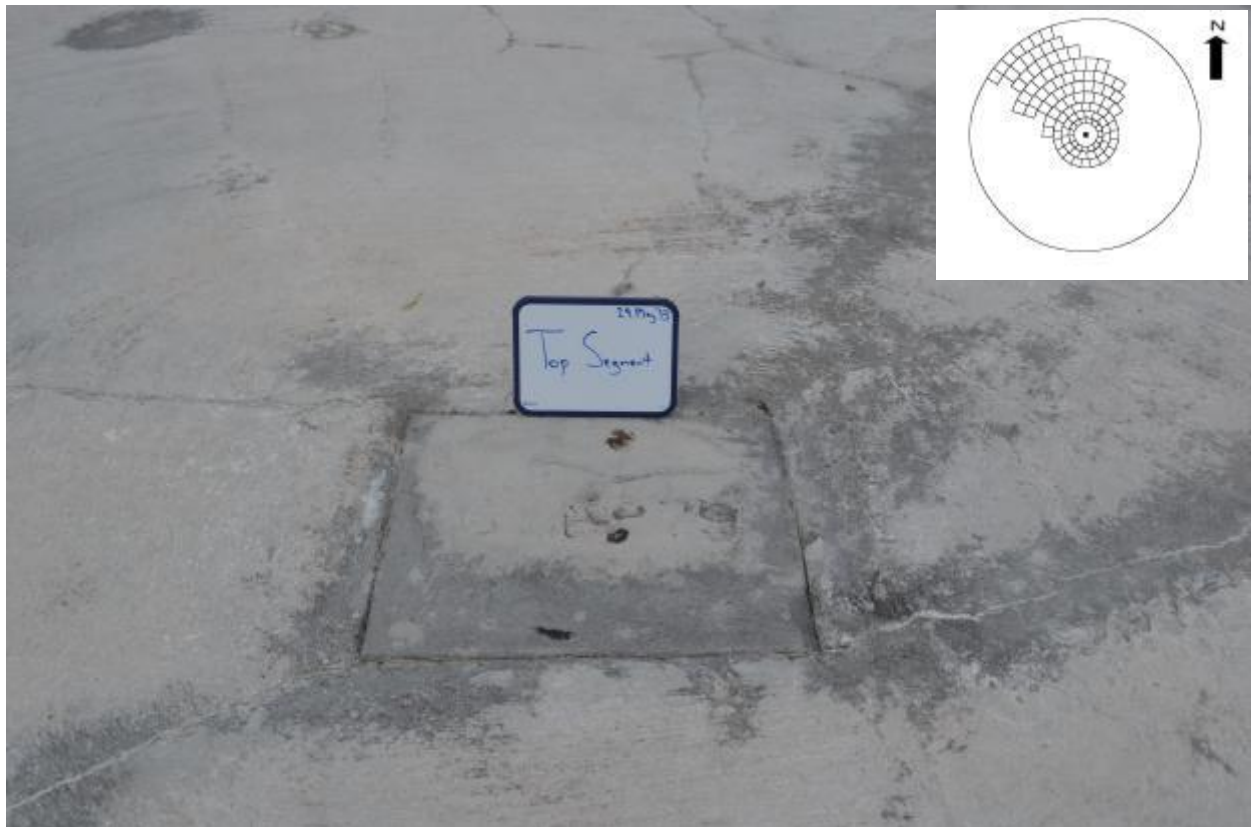
CAP SECTION LOCATION: Panel L (Top Segment)

Several surface cracks crisscrossing the segment with minor chipped “spalled” edges. The most significant cracks originate from the corners of the center top cap section of concrete.
